## PS752 Accident Investigation

# FACTUAL REPORT

July 2020

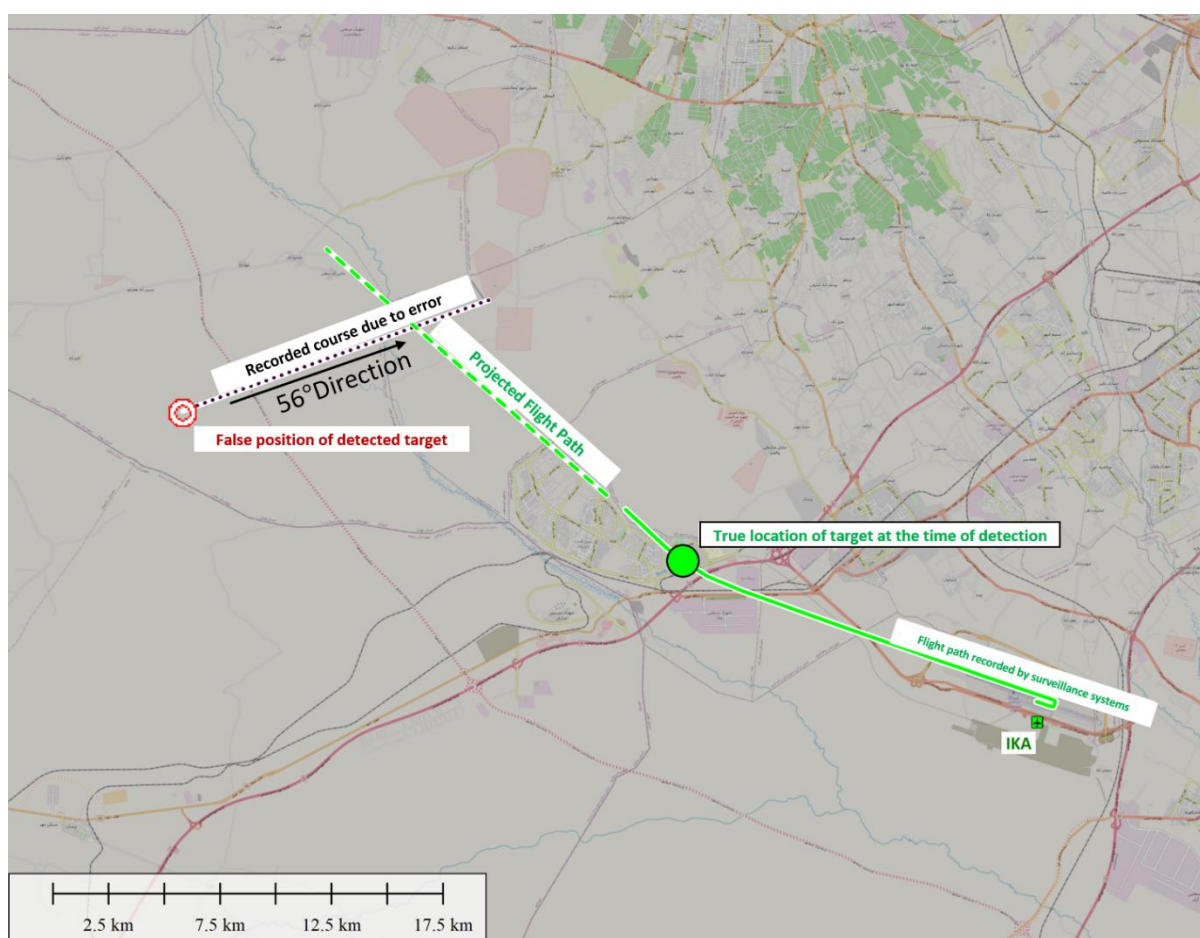
<sup>4</sup> After the relocation of one of the air defense units of Tehran, clearly causing a change in its heading, a failure occurred due to a human error in following the procedure of system north alignment. As a result, a 107-degree error was induced in the system. As such, while the PS752 aircraft was flying, the direction of objects and targets detected by this system was being observed with an increase

8. At 02:43:56, the air defense unit operator detected a target at his 250-degree azimuth, flying on a 52-degree course. At the same time, after takeoff, the PS 752 had been flying towards the defense system from a 143-degree azimuth. The aircraft was passing a 309-degree course.
9. At 02:44:21, the operator notified the specifications of the detected target to the Coordination Center over the communication network (note paragraph 10 on the communication status). The target was, in fact, the very PS 752 flight departing from IKA, detected by the system as a target approaching Tehran from approximately the southwest. (Figure 2)

Figure 2- The true location of the aircraft at the time of detection and the false location and course due to north alignment error

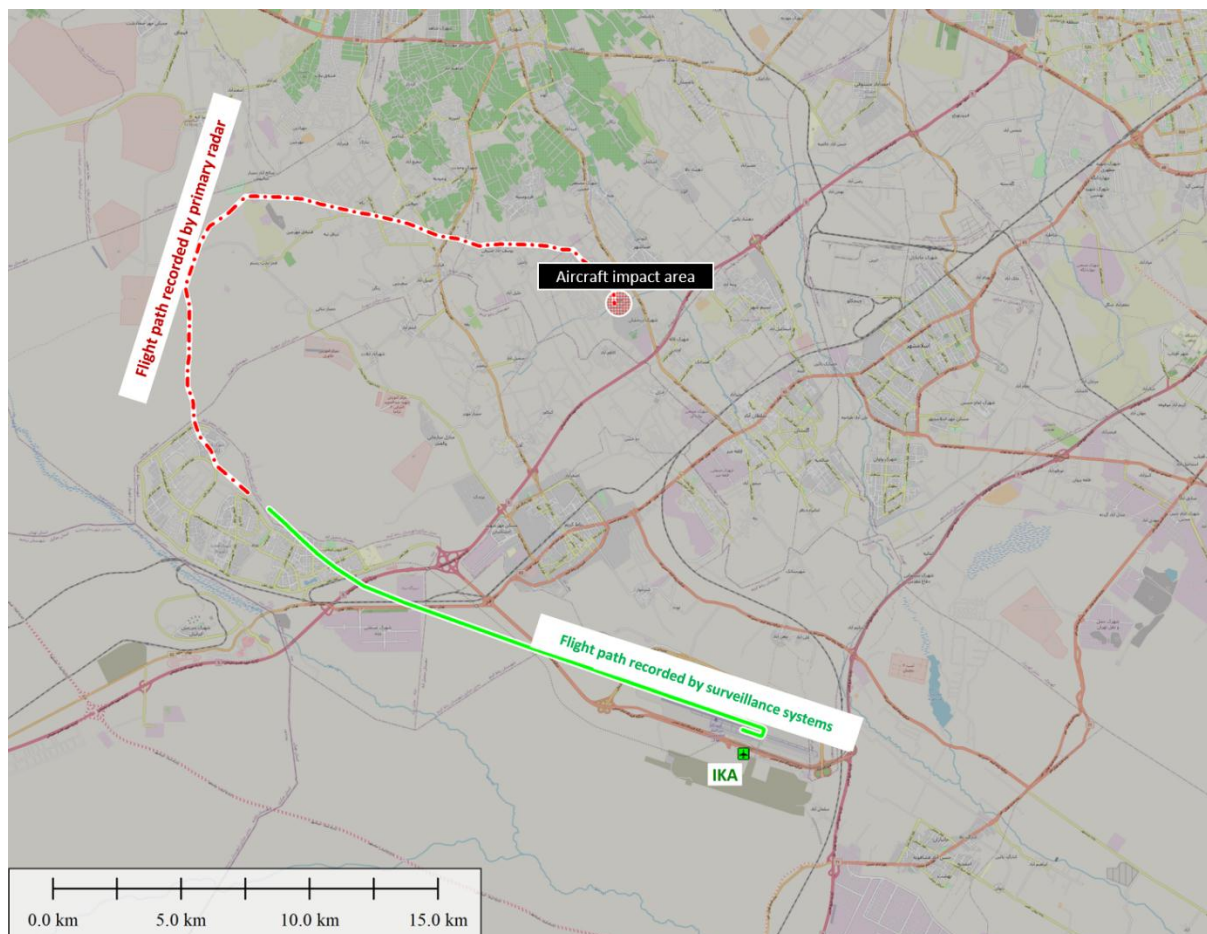
19. The aircraft turned to the right, the route of which can be seen in Figure 6. Due to the radio communication disconnection, there is no information on the aircraft altitude during the time when it was being detected by the Primary Surveillance Radar.
20. The evidence shows that at about 02:46:11, a fire broke out on the aircraft, which was intensifying.
21. At 02:48:23, the aircraft crashed into a playground in Khalajabad near Shahedshahr area at the location marked in Figure 6. An explosion occurred the moment the aircraft impacted the ground. The aircraft then kept hitting the ground and bouncing on a route towards the airport, making the aircraft pieces, victims' properties, objects and body remains disintegrate completely in a vast area near a residential complex, recreational and sports park, gardens and the surrounding agricultural land.

Figure 6- The aircraft impact area

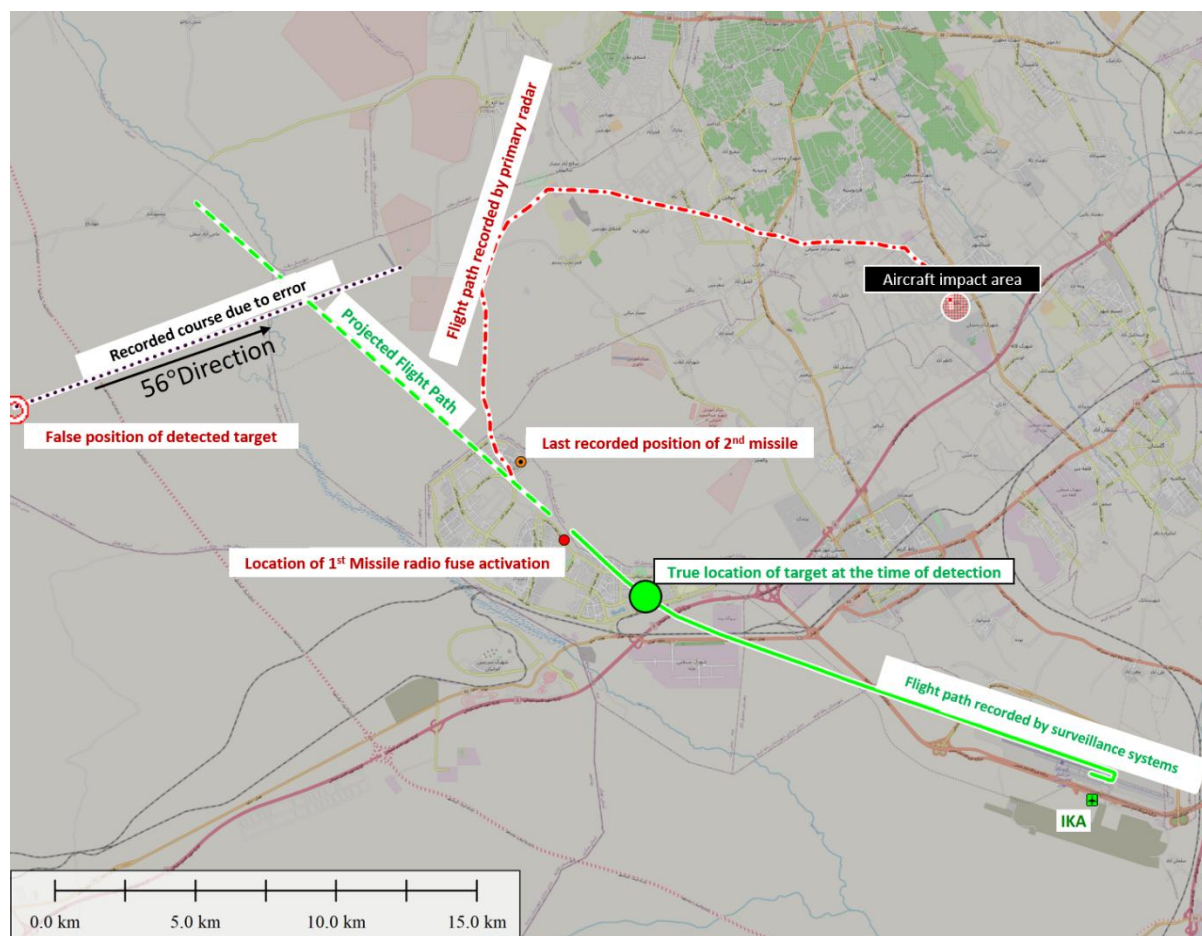
*A complete overview of the information, as well as the events on the PS752 flight path are depicted in Figure 7.*

Figure 7- Complete overview of available information about the flight route and key events

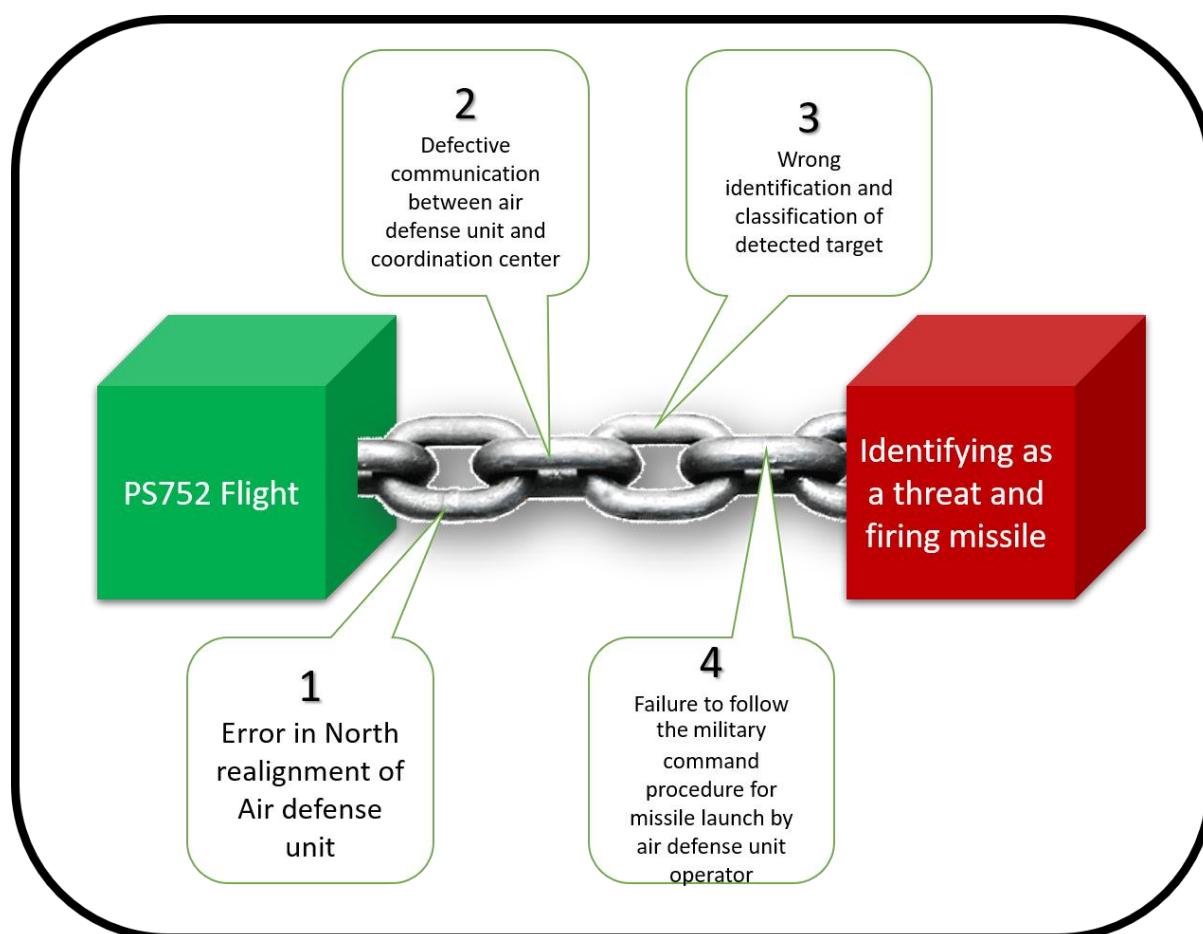
1. The sequence of events clearly shows the occurrence of a chain of events initiated by a human error<sup>8</sup>. Up to this point, some important contributing links in the chain of events have been identified, which have led to targeting the aircraft mistakenly<sup>9</sup>. Figure 8 illustrates the chain of key events identified, that if each had not arisen, the aircraft would not have been targeted. It should be noted that some new links may be found by reading out the flight recorders.

Figure 8- The chain of events leading to targeting the PS752 flight

<sup>9</sup> - At the time of publishing this report, the measures adopted by Iran's military sector focusing on each one of the links in the accident chain indicate that the likelihood of occurrence of a similar event has been reduced to an improbable level. Therefore, the safety level of airspace for commercial flights from the viewpoint of misidentification is now in normal conditions.
